Infrared Thermographic Inspection Report

Mr. John Doe

Allan's Place

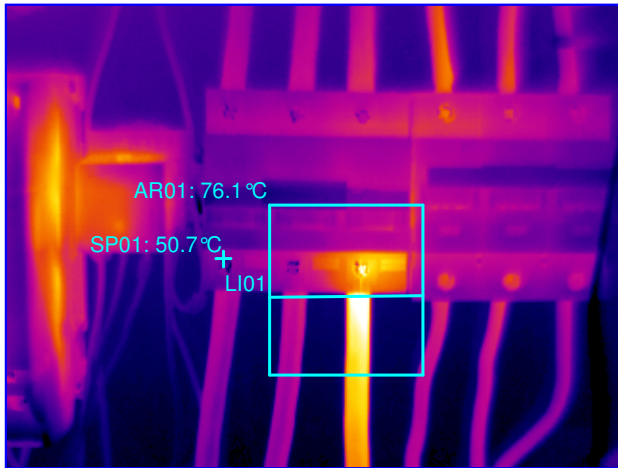
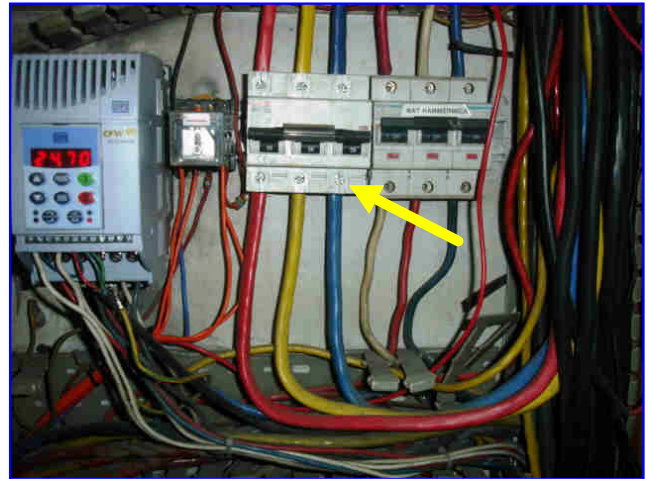
Exception number: 1

Substation / Area:	Main LT Room
Feeder /equipment:	Panel 6-Decanter 2-Breaker
Fault description:	Bottom of the breaker
Phase:	Blue

Exception temperature :	76.1 °C
Reference temperature :	50.7 °C
Temperature difference :	25.4

CATEGORY**B****Thermographer comments**

The cable needs to be cleaned and reconnected.

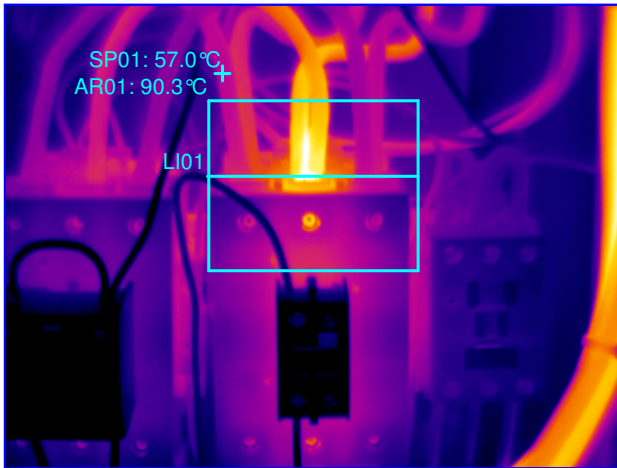
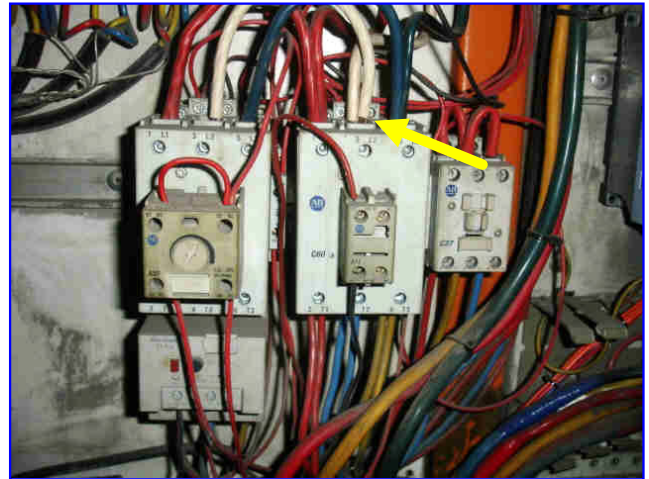
Exception number: 2

Substation / Area:	Main LT Room
Feeder /equipment:	Panel 5-Hammer Mill 1-Contactor
Fault description:	Top of the contactor
Phase:	White

Exception temperature :	90.3°C
Reference temperature :	57.0°C
Temperature difference :	33.3

CATEGORY**B****Thermographer comments**

The cables need to be cleaned and reconnected.

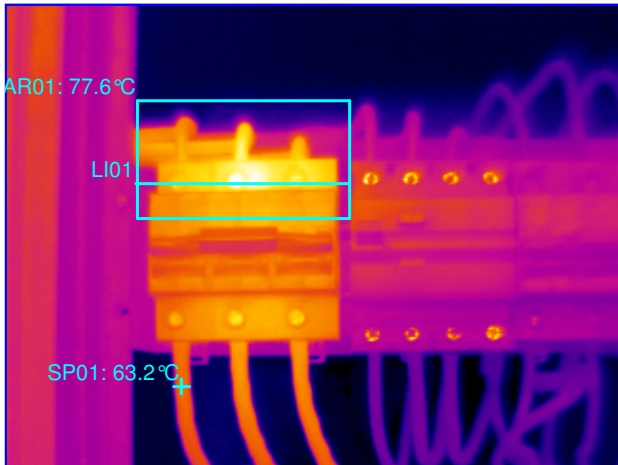
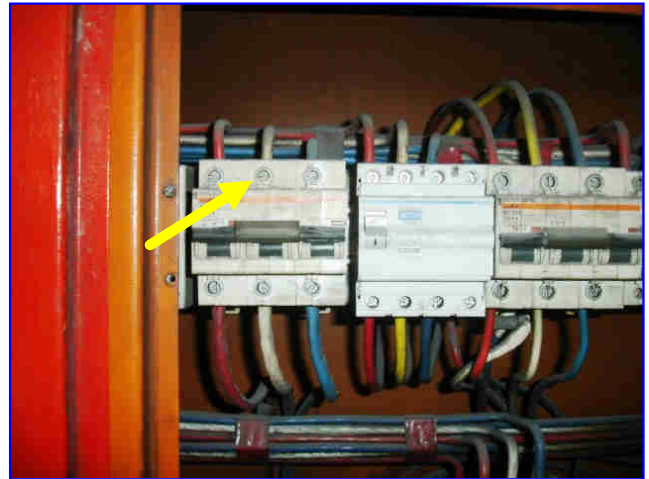
Exception number: 3

Substation / Area:	Boiler House-Main Db
Feeder /equipment:	Boiler 7-Draft Fan Breaker
Fault description:	Top of the breaker
Phase:	White

Exception temperature :	77.6°C
Reference temperature :	63.2°C
Temperature difference :	14.5

CATEGORY**C****Thermographer comments**

The cable needs to be cleaned and reconnected.

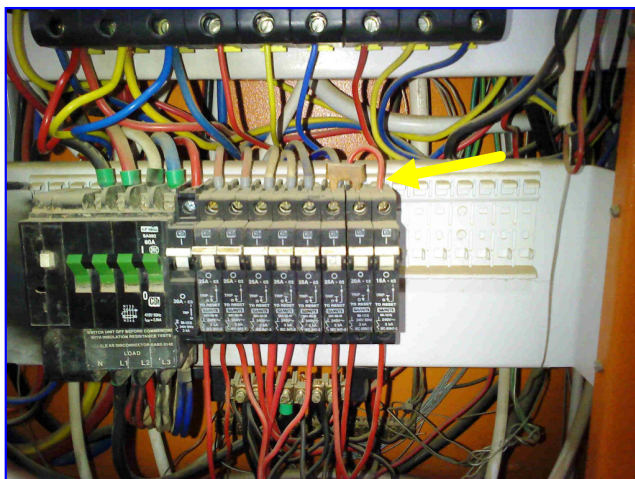
Exception number: 4

Substation / Area:	Hostel Kitchen Db A
Feeder /equipment:	Bottom Row-Circuit Breaker 8
Fault description:	Incorrect size link cable
Phase:	n/a

CATEGORY**Inv.****Thermographer comments**

The link cable needs to be the same size as the feeder cable.

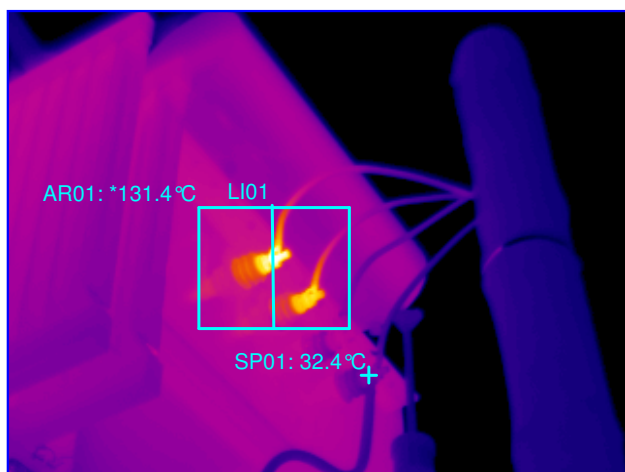
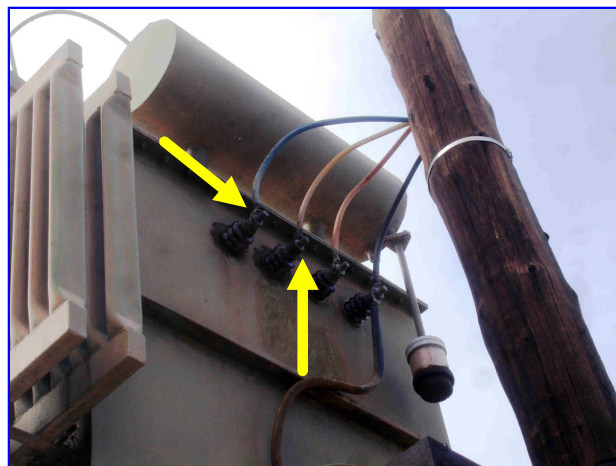
Exception number: 5

Substation / Area:	Hostel Transformer Yard
Feeder /equipment:	Pole Transformer-Secondary Side
Fault description:	Bushing connections, hot
Phase:	White,Blue

Exception temperature :	*131.4°C
Reference temperature :	32.4°C
Temperature difference :	*99.0

CATEGORY**A****Thermographer comments**

The bushings on the transformer are leaking oil and the cable lugs need to be cleaned and reconnected.
