Infrared Thermographic Inspection Report

Mr. John Doe

Company	Allan's Place
Inspection date	00/00/2014
Calibration date	18/06/2013
Contact (Initials and surname)	Mr. John Doe
Contact Tel. No.:	
Contact Cell No.:	
Contact E-Mail:	
Address	
City (Site Location):	
Nature of Business:	
Observer Name

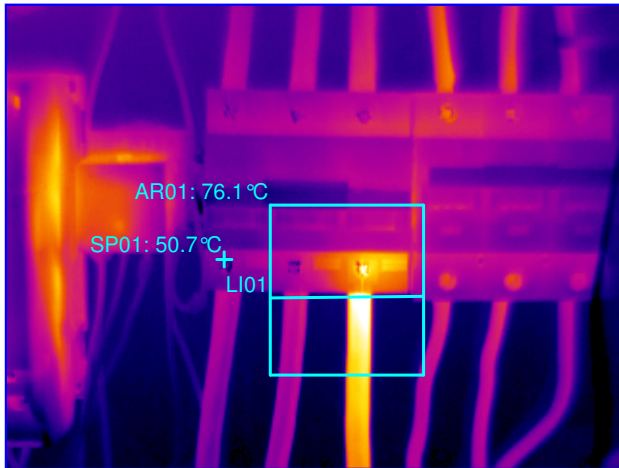
Exception number: 1

Substation / Area:	Main LT Room
Feeder /equipment:	Panel 6-Decanter 2-Breaker
Fault description:	Bottom of the breaker
Phase:	Blue

Exception temperature :	76.1 °C
Reference temperature :	50.7 °C
Temperature difference :	25.4

CATEGORY**B****Thermographer comments**

The cable needs to be cleaned and reconnected.

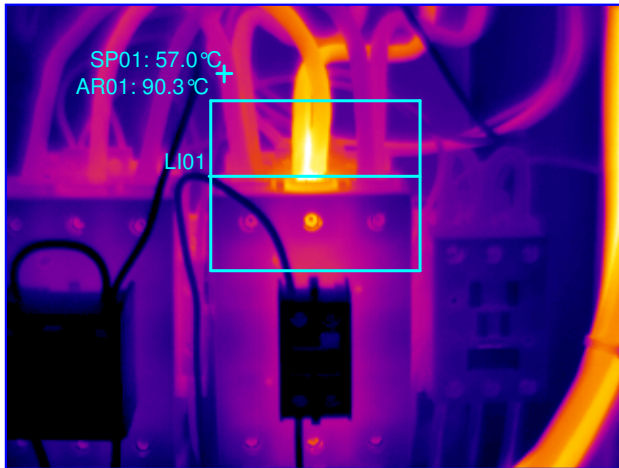
Exception number: 2

Substation / Area:	Main LT Room
Feeder /equipment:	Panel 5-Hammer Mill 1-Contactor
Fault description:	Top of the contactor
Phase:	White

Exception temperature :	90.3°C
Reference temperature :	57.0°C
Temperature difference :	33.3

CATEGORY**B****Thermographer comments**

The cables need to be cleaned and reconnected.

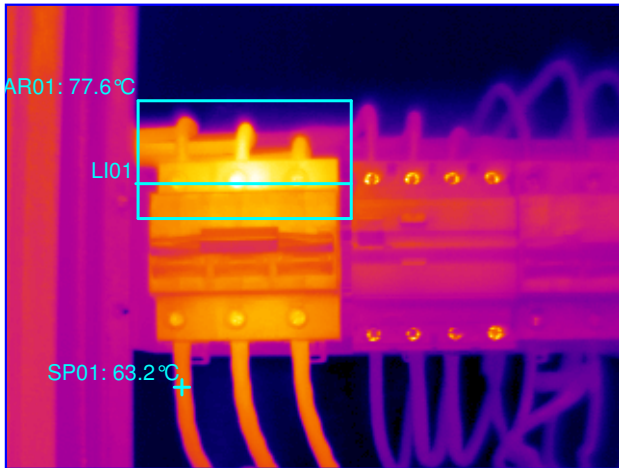
Exception number: 3

Substation / Area:	Boiler House-Main Db
Feeder /equipment:	Boiler 7-Draft Fan Breaker
Fault description:	Top of the breaker
Phase:	White

Exception temperature :	77.6°C
Reference temperature :	63.2°C
Temperature difference :	14.5

CATEGORY**C****Thermographer comments**

The cable needs to be cleaned and reconnected.
