Infrared Thermographic Inspection Report

Mr. John Doe

Allan's Place

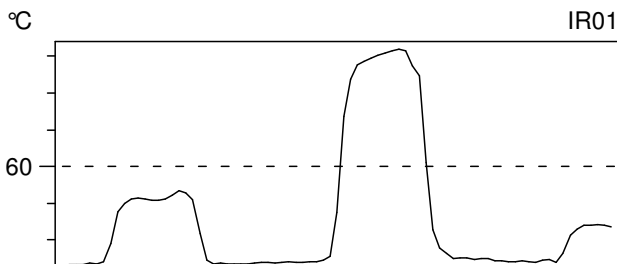
Exception number: 1

Substation / Area:	Main LT Room
Feeder /equipment:	Panel 6-Decanter 2-Breaker
Fault description:	Bottom of the breaker
Phase:	Blue

Exception temperature :	76.1 °C
Reference temperature :	50.7 °C
Temperature difference :	25.4

CATEGORY**B****Thermographer comments**

The cable needs to be cleaned and reconnected.

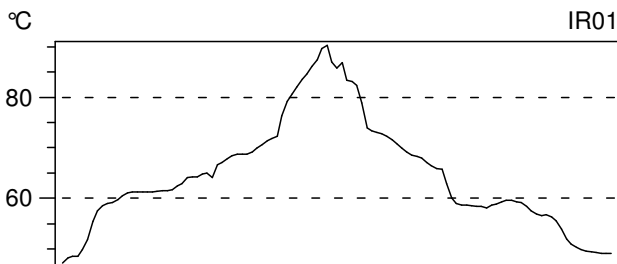
Exception number: 2

CATEGORY**B****Thermographer comments**

The cables need to be cleaned and reconnected.

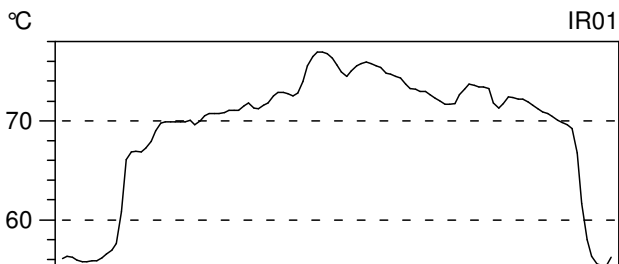
CATEGORY**C****Thermographer comments**

The cable needs to be cleaned and reconnected.

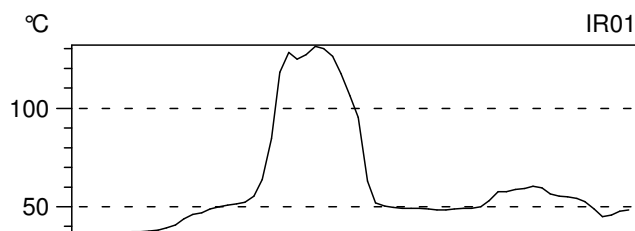
CATEGORY**A****Thermographer comments**

The bushings on the transformer are leaking oil and the cable lugs need to be cleaned and reconnected.
